Cold Welding Repair Based on ASME PCC-2-2018, and The Effectiveness for the Applied Repair

Lukman Hartono

ABSTRACT

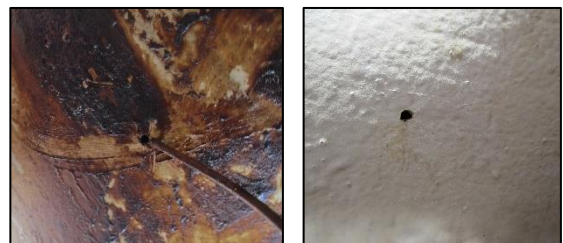
A real case of repair using cold welding method was used on the hole defects on pipeline in PT. Pertamina EP Tambun. The condition of the pipeline was empty inside as they were using an alternate pipe for continuation of the production process of the plant, thus the repair does not need to determine any precaution on previous flowing component. The hole defects documentation is shown on Figure 3.

Figure 3. Hole in the Pipeline

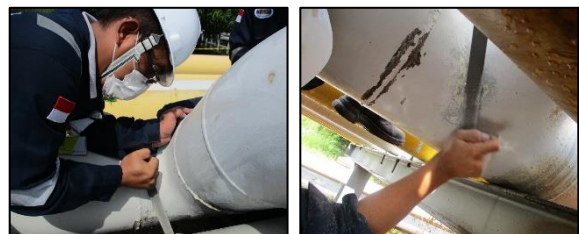
Figure 4. Surface Preparation

2. Surface Preparation is carried out which includes cleaning the pipe surface and patching material from all kinds of dust, oil/grease, dirt from the environment (spatters, tack weld residue etc.) and rust and from old paint, based on SSPC-SP2/SP3 standard.

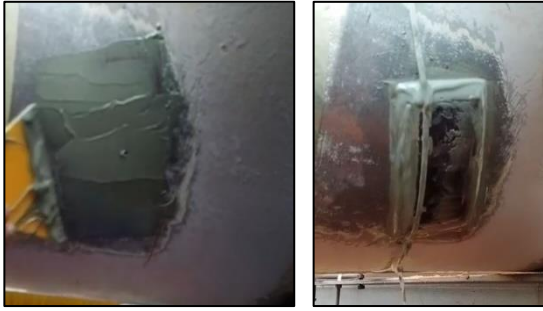
Figure 5. Adhesive and Patching Application

4. Apply the fully mixed Metal Adhesive and Activator to the leaking pipe furthermore apply the coated patch which is a patching plate that has been adjusted to the size of pipe and coated by metal adhesive mix. Wait for 2-3 hours to dry completely (full curing time). Then Install the Bolts on Patching. Make sure there is no more leakage from the pipe.

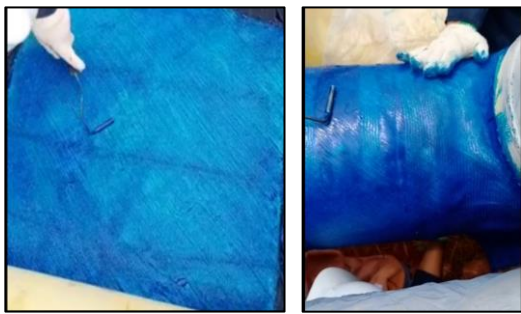
Figure 6. FRP (Composite Wrapping) Application

6. Application of FRP: Saturate Coating Material into Glass Fiber, then apply the FRP to the surface of the tank or pipeline evenly,

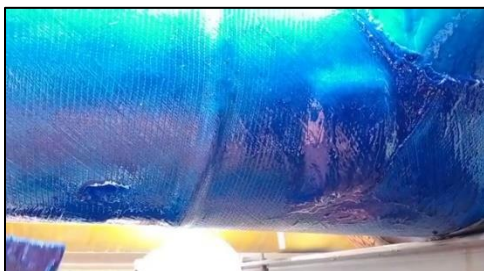
Figure 7. Results of Cold Welding on Pipeline

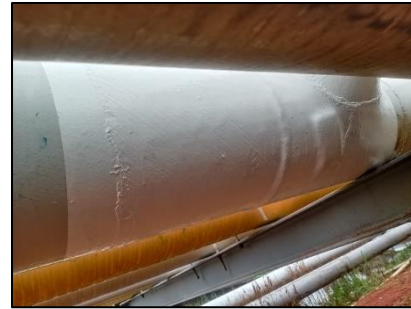
Figure 8. Finish Coating on Cold Welding Works

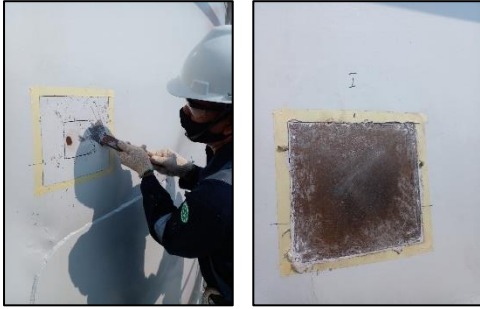
Figure 10. Surface Preparation

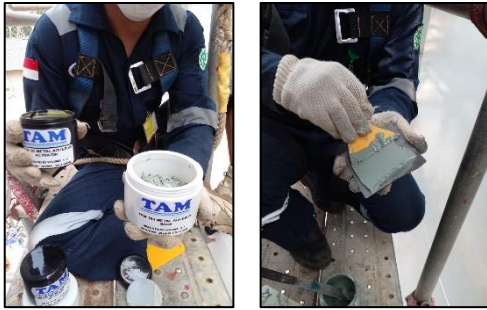
Figure 11. Metal Adhesive and Patching Preparation

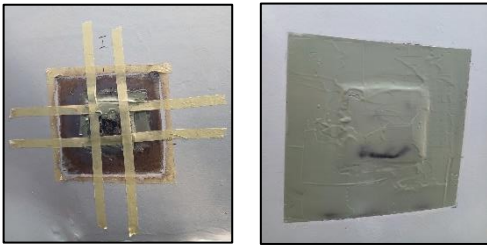
Figure 12. Applied Patching and Metal Adhesive Finish

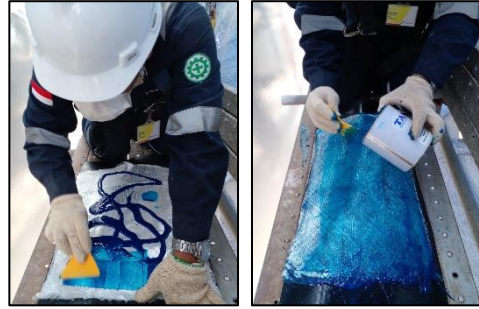
Figure 14. FRP (Composite Wrapping) Preparation

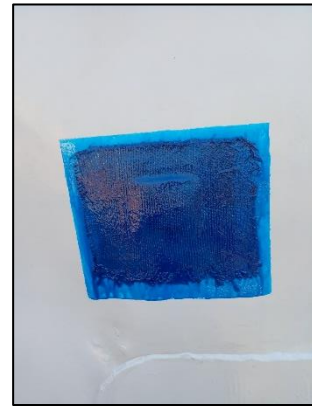
Figure 15. Applied FRP (Composite Wrapping) on Tank

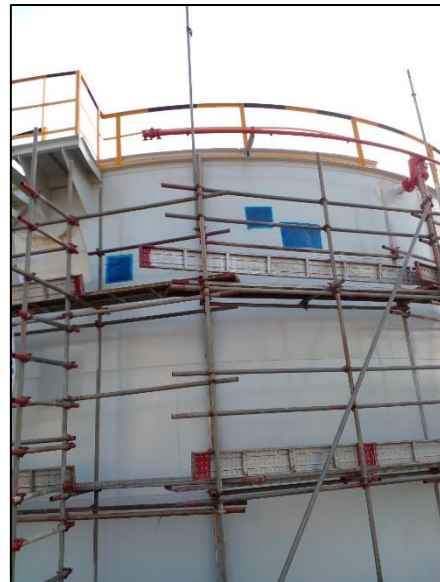
Fig 16. Applied Cold Welding works on all Tank Defects

After the previous cold-welding repair on the pipeline and tank has been done, the repaired area is carefully checked. The system connected to the object is then turned on and thoroughly observed for over 1 month period of time. There was no sign of any repair break down and no leakage was found. It is concluded that the cold welding did repair the holes or the defects effectively.

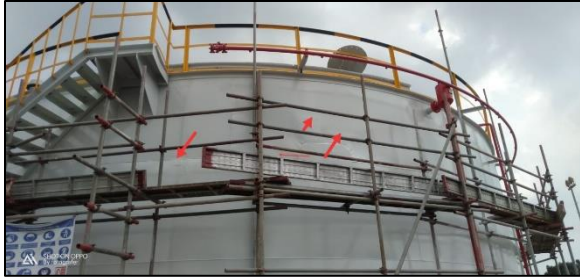
Fig 17. Finish Coating on Cold Welding Works
